# Safety Inspection Report

Annual Inspection

## Stag Recreation Ground Play Area

17 May 2024

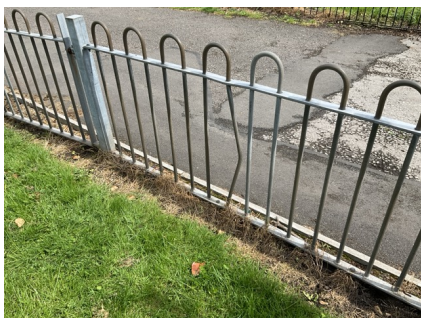
Item is bent.

No reasonably practicable action is identified.

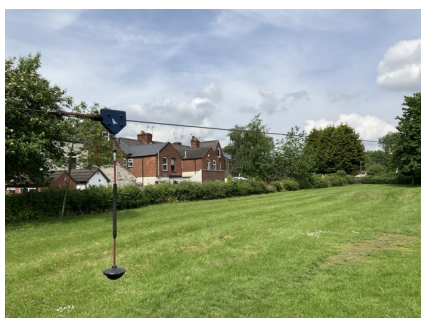
Cable is loose.

Repeat finding. This cableway is bouncing suggestive that a re-tension is required. It requires a maintenance check/service and a retighten as per dismantling finding.

Read the notes for further action.

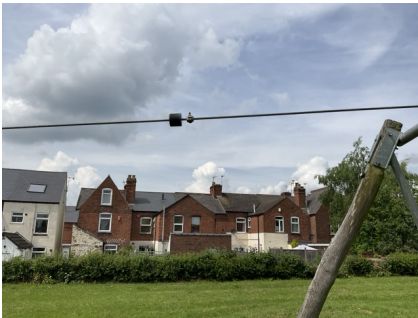
The supporting components should be dismantled and inspected according to the manufacturer's instructions. This will need doing on a regular basis, as defined by the manufacturer. This can lead to a high risk if no action is taken.

Dismantle and inspect according to manufacturer's instructions.

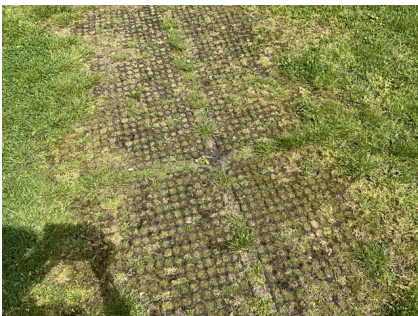
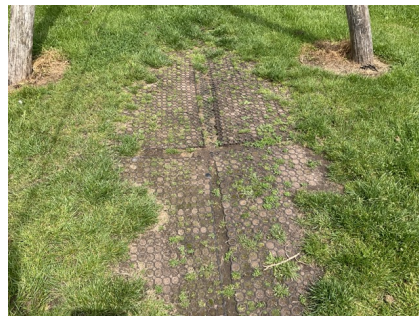
Surface needs repair.

Grass mats damaged.

Repair.

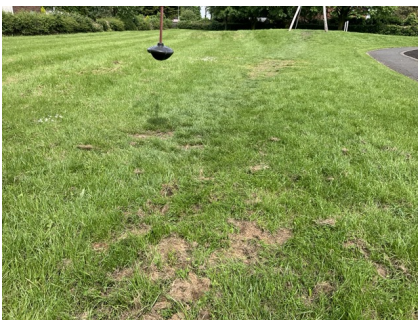
Surface is uneven.

Surface rises up as traveller moves towards far end (from start ramp). Monitor. If cable loosens in tension there could be less than 350 mm ground clearance.

Read the notes for further action., No reasonably practicable action is identified.

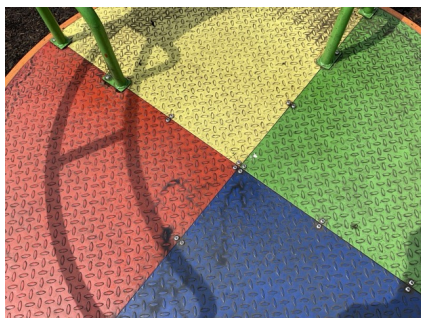
Bearings require service.

Service the bearings.

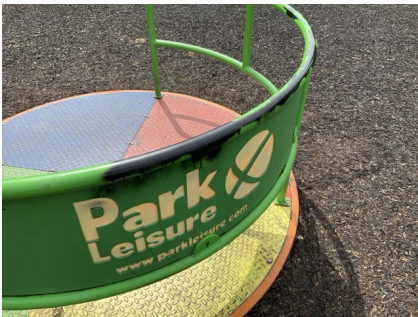
There is graffiti on the unit.

Neil C to Clean

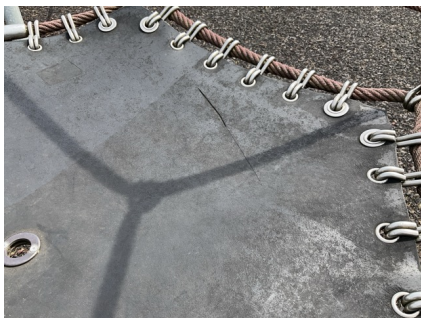
Item is damaged.

Small abrasion cut. Repair.

Repair.

Neil C to Repair

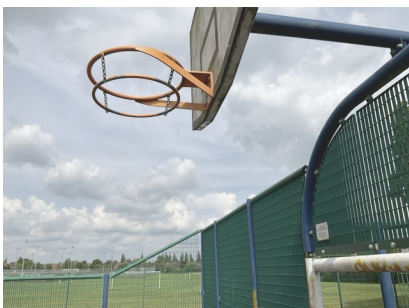
Item has some parts missing.

Read the notes for further action., Replace the missing parts.

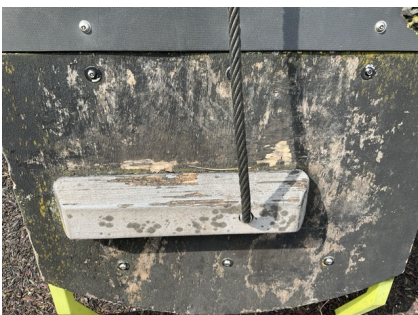
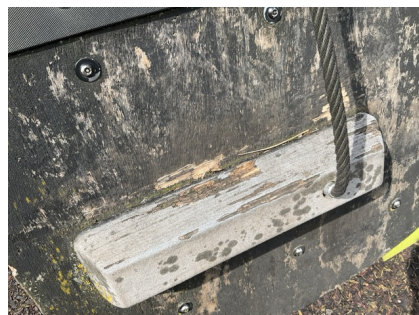
Item is worn.

Climbing wall back board is splintering. The block is also decaying. Replace backboard and rub down block or replace.

Repair., Replace.

Can we find out manufacturer and then request a quote please Julie

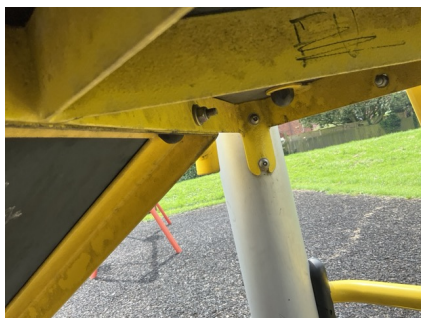
Cap missing.

Replace.

Neil C to replace caps-ask Cliff if they have any spares?

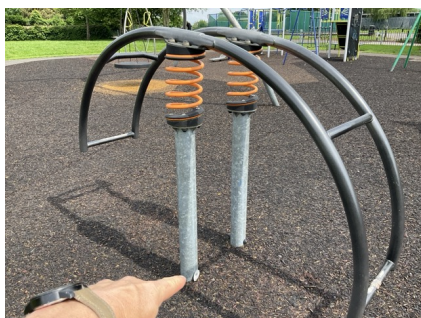
Loose in ground.

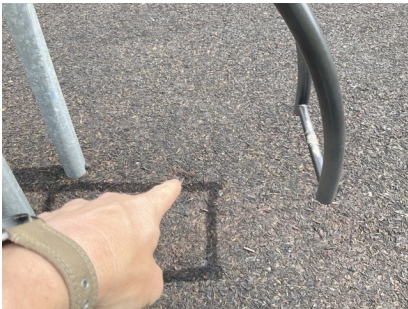
The surface is damaged.

Under rocker ends. Monitor and repair as necessary.

Repair.

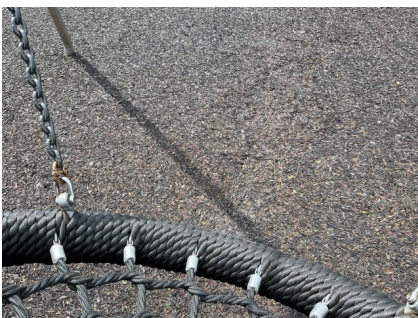
Surface needs repair.

Foot drag is wearing under the basket. Plan repair of bonded rubber mulch.

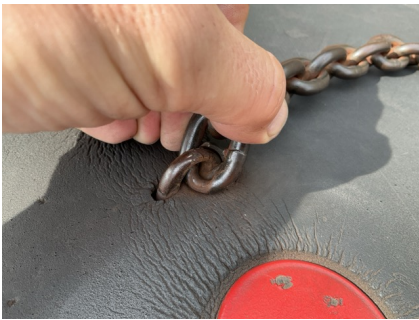
Given forces involved with this asset the level of wear in the connectors now means there is a possibility of failure in the future. Replace connectors and attached chain links which in some cases are beyond 40% worn.

Read the notes for further action., Replace worn parts.

Neil C to replace-again can we ask Cliff for assistance on this

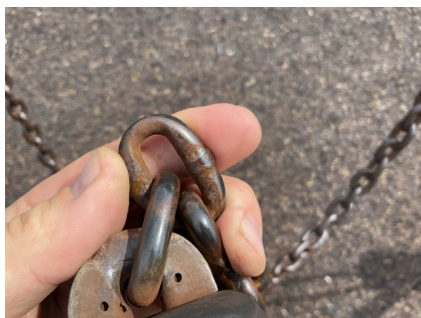
Some chain wear.

Monitor for further deterioration and replace before 40% wear.

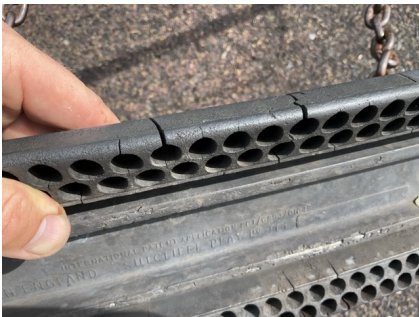
The swing seat has been damaged, but does not require immediate replacement.

Monitor and replace when hard material is exposed.

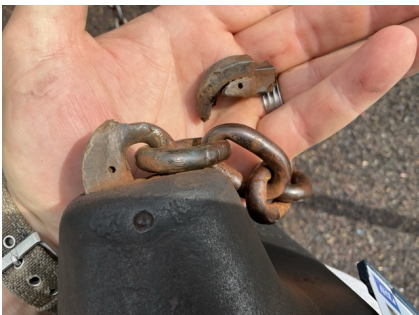
Swing D-shackles are worn.

Plastic cover/bush worn through. Replace.

Read the notes for further action., Replace.

[Ask Neil C to replace-order any parts required](#)

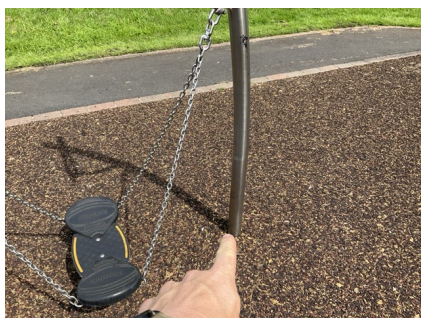
Loose in ground.

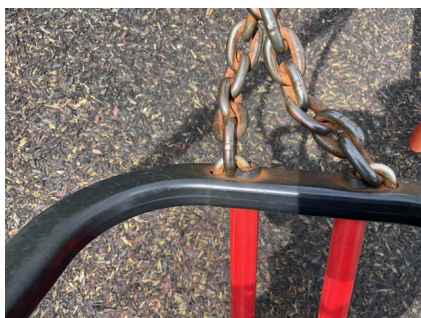
Item has some parts missing.

Rubber fixing to D-rings. Schedule replacement.

Read the notes for further action., Replace the missing parts.
