Safety Inspection Report

Annual Inspection

Knowle Park Recreation Ground

17 May 2024

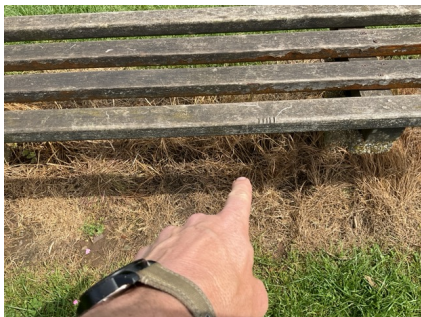
Hole(s) found.

Fill in.

Neil to fill in hole

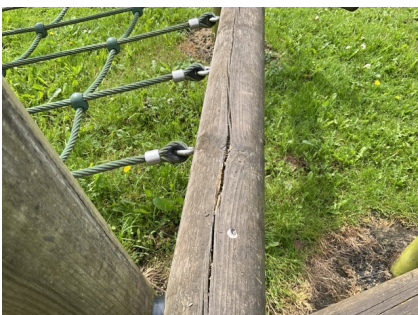
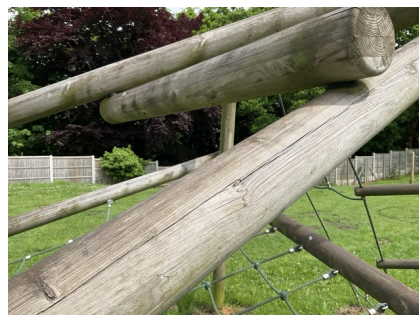
Some decay in main support net post. Monitor.

Has this ever been picked up by our weekly inspections?

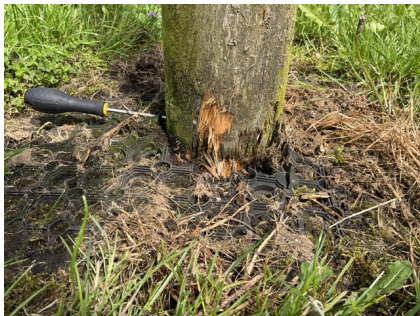
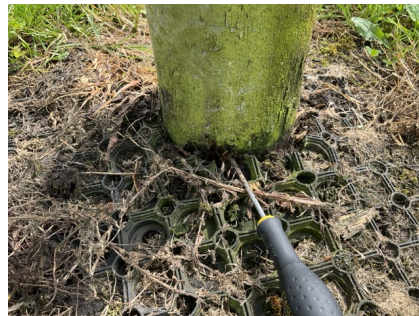
Strimmer damage is present on posts, allowing water to enter and timbers to soften. It can also remove the protective envelope around the timber. Prevent further damage and check timbers for decay throughout the year.

The post appears heavily strimmed. There is some decay setting in. Monitor as this may deteriorate quickly. Plan for replacement.

We need to find 3 quotes for replacement of this please Julie

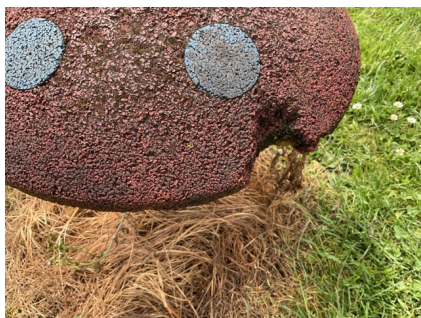
Item has dog damage.

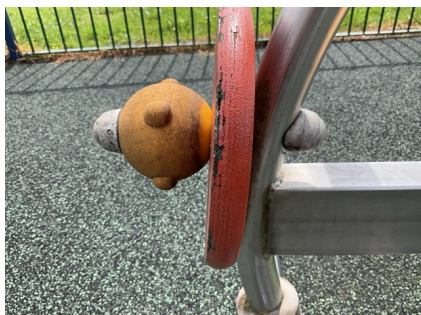
Fixtures loose or missing.

Front of rocker bolt has loosened. Resecure.

Neil C to fix

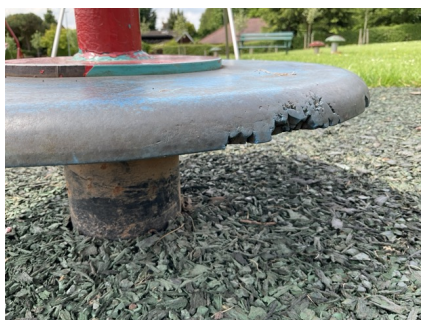
Item is damaged.

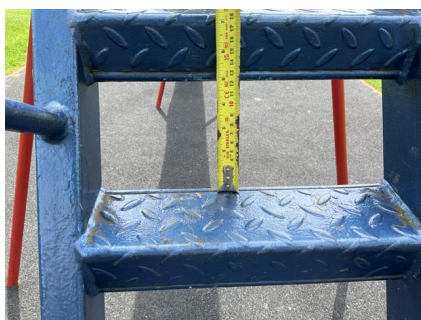
Access fails the entrapment requirements.

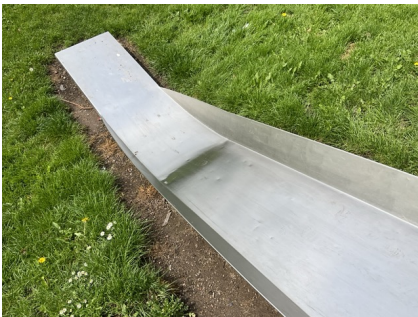
Item is damaged.

Slide bed. Dented. Monitor for cracks.

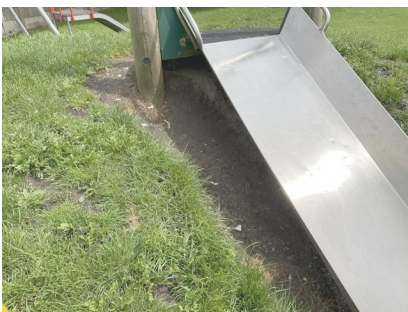
Surface is wearing.

Repair.

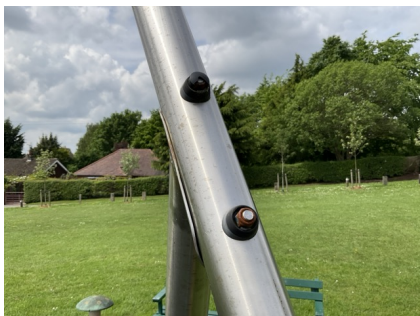
Cap missing.

Replace.

Again Neil C to replace caps please

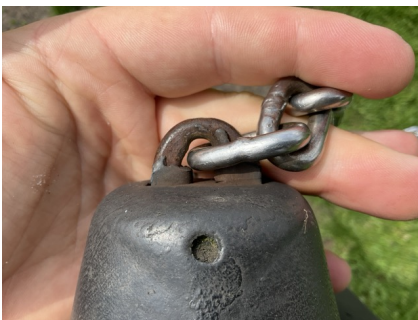
A couple are quickly approaching 40%. Inspector advises planning for replacement (s).

As advised, can we start looking at costs for replacing chain link connectors?

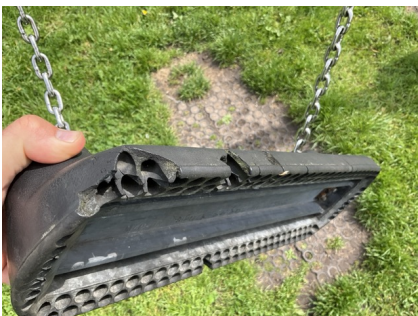
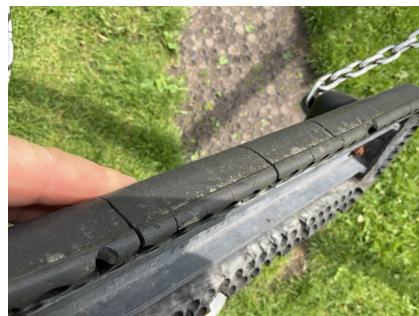
Swing seat rubber is deteriorating / degrading.

Damage to underside. Monitor.

Read the notes for further action., Replace when metal is exposed.

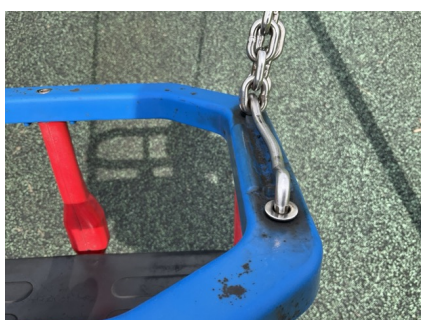
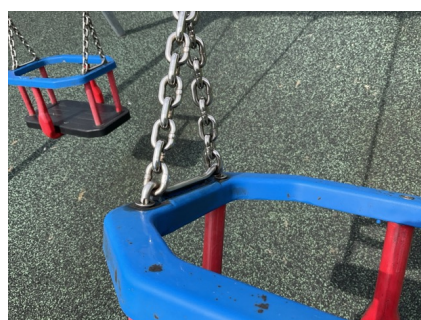
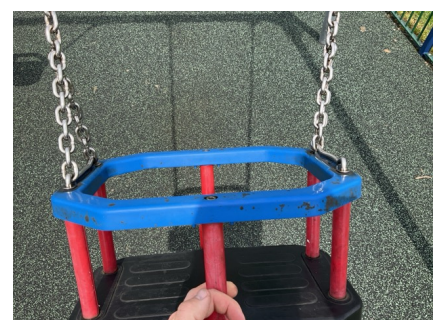
Metal bar securing swing suspension has bent. This has enabled the chain to slide along back to the other suspension. This creates an unstable swing and potential entrapment. Re-fit a new bar or replace the cradle.

Neil C to replace cradle with spare swing seat please

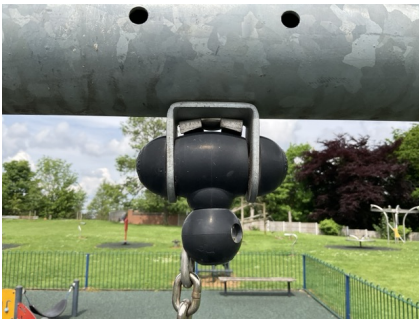
The covers should be removed from the fitting at the top of the chain annually and the shackle bolt should be checked for wear. Check the security of the fittings too.

Undo and check for chain wear on a regular basis.

Replace at 70% of original diameter (30% wear). Check the security of the fittings.

Neil C to check please-check ALL fittings at least once a month.

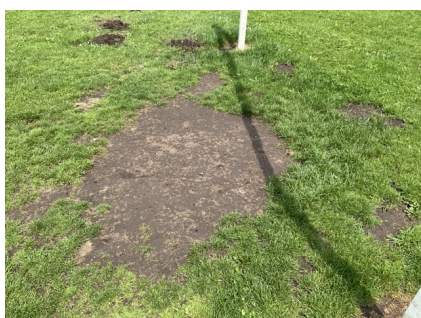
Worn ground areas.

Can we investigate the costs of astroturf install at this location. Same size as the one at Stag Ground, Neil C can get you the measurements

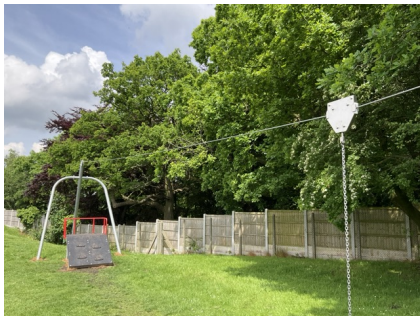
Inspector advises cable is dismantled and serviced. Additionally this year the internals on the travellers appear to show signs of wear. Service the traveller.

We should look into the cost for annual servicing of this type of large equipment so we can budget for it in the future

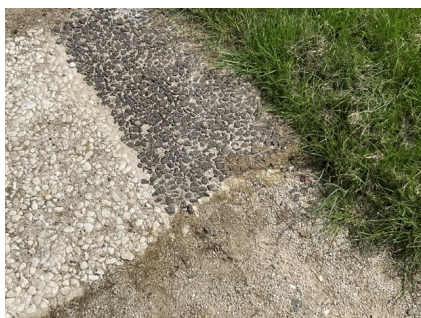
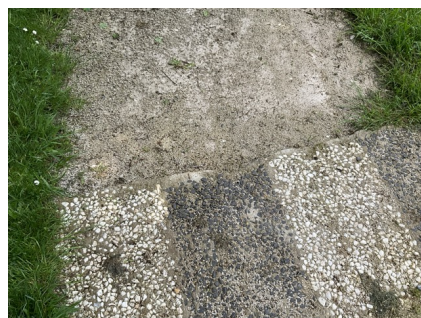
Surface needs repair.

Neil C to fill in please

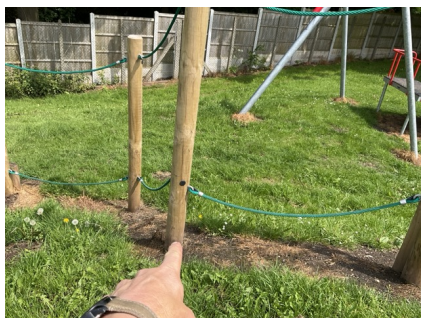
Loose in ground.
