# Safety Inspection Report

Annual Inspection

## Stag Recreation Ground Play Area

17 May 2024

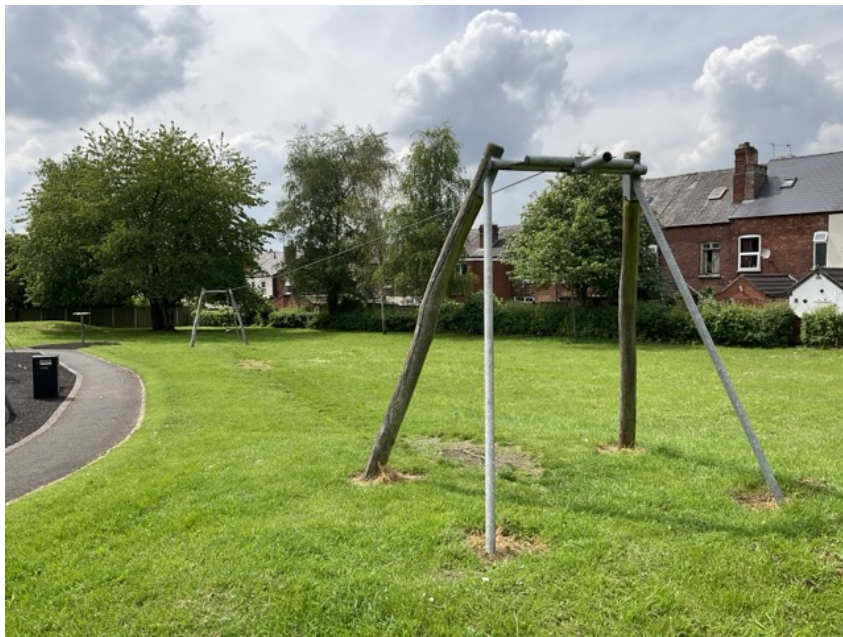
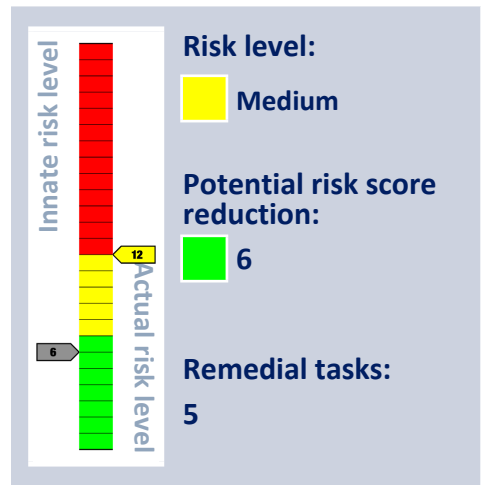
# Cableway

Cable is loose.

Surface needs repair.

Grass mats damaged.

Surface rises up as traveller moves towards far end (from start ramp). Monitor. If cable loosens in tension there could be less than 350 mm ground clearance.

Repair.

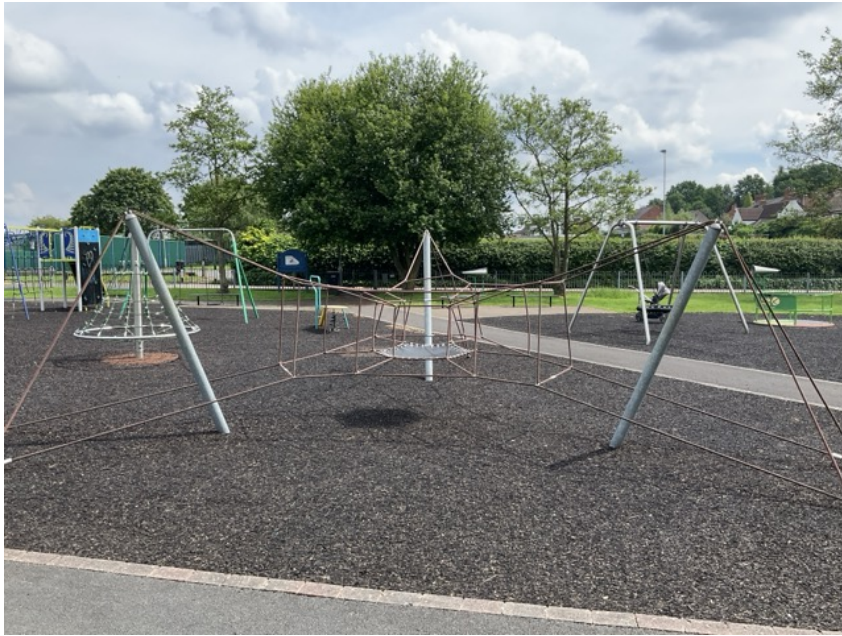
# Climber - Net - Spider's Web

Item is damaged.

Small abrasion cut. Repair.

Repair.

Neil C to Repair

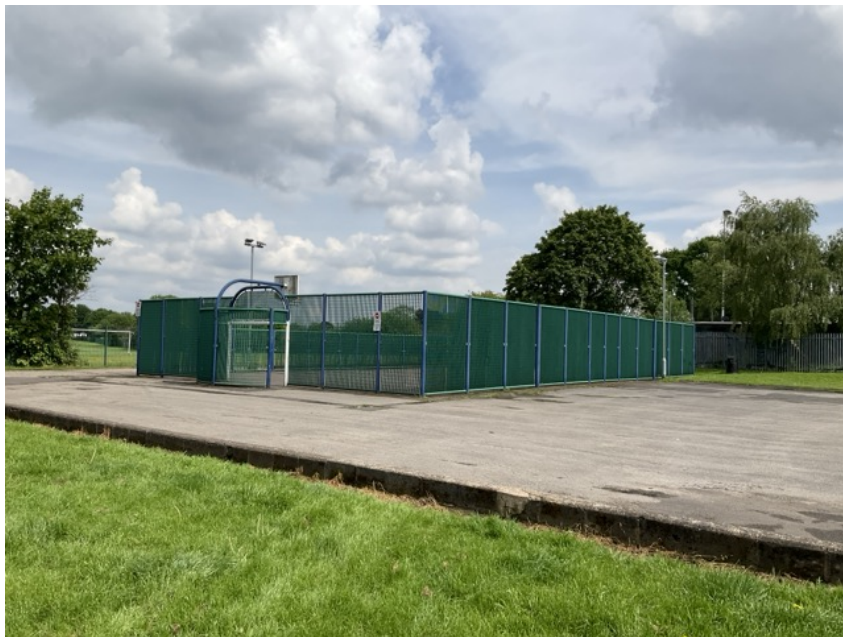
# MUGA

Item has some parts missing.

Read the notes for further action., Replace the missing parts.

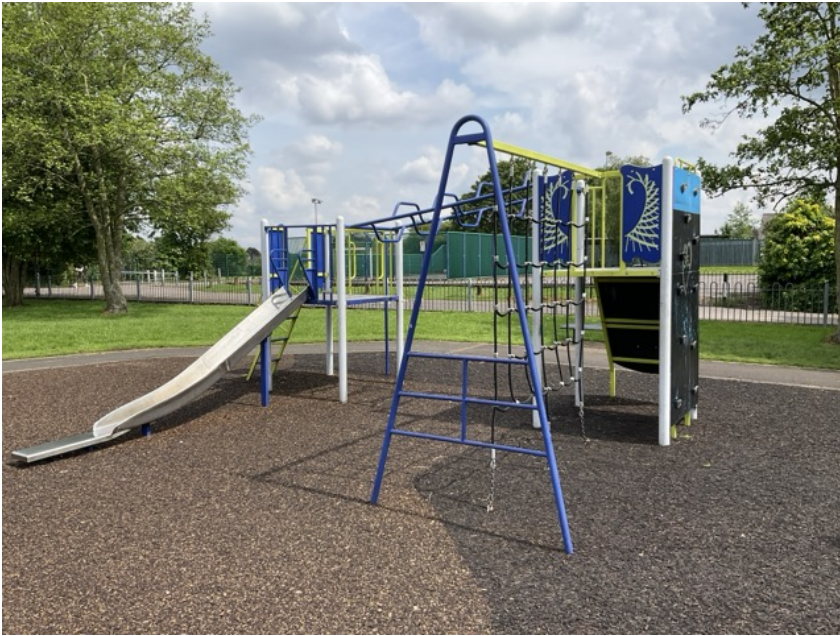
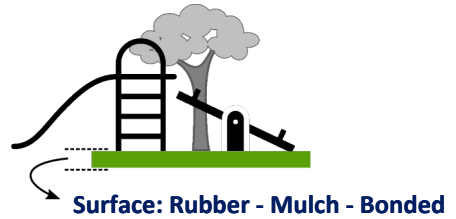
# Multiplay - Junior

Item is worn.

Climbing wall back board is splintering. The block is also decaying. Replace backboard and rub down block or replace.

Repair., Replace.

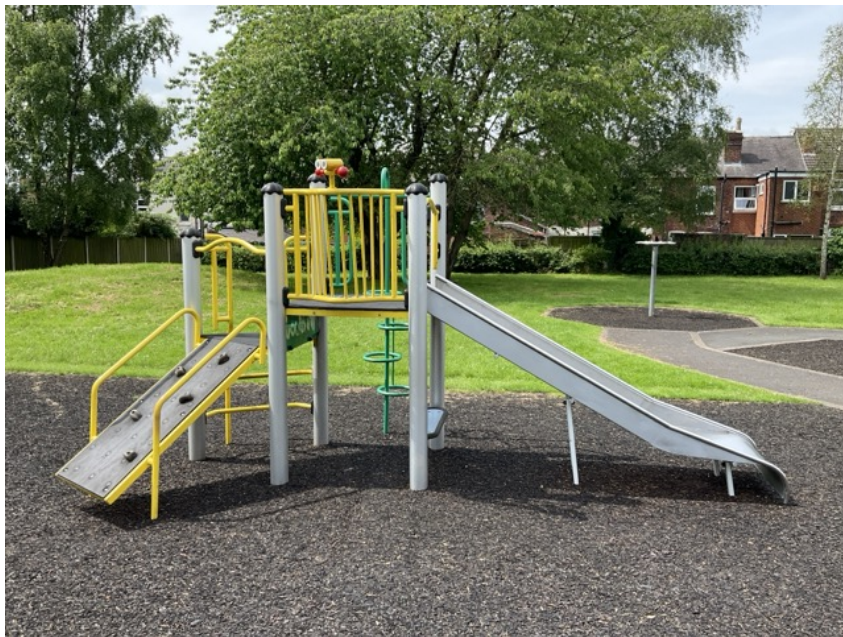
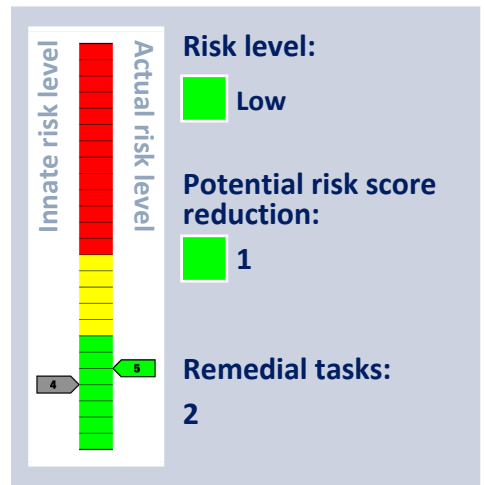
# Multiplay - Toddler

Cap missing.

Replace.

Neil C to replace caps-ask Cliff if they have any spares?

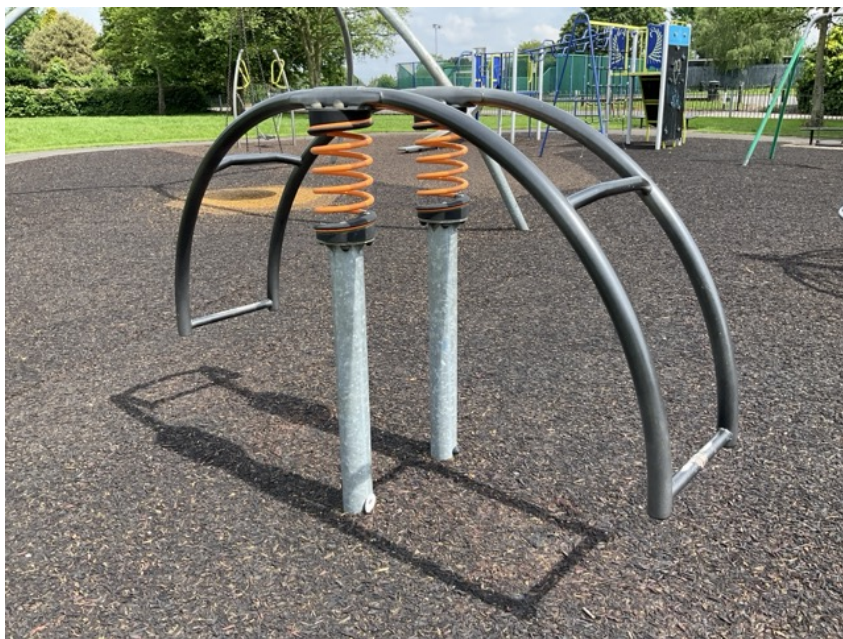
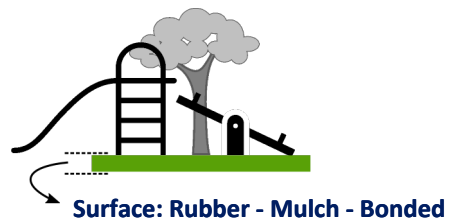
# Rocker - Seesaw - Standing

Loose in ground.

The surface is damaged.

Under rocker ends. Monitor and repair as necessary.

Repair.

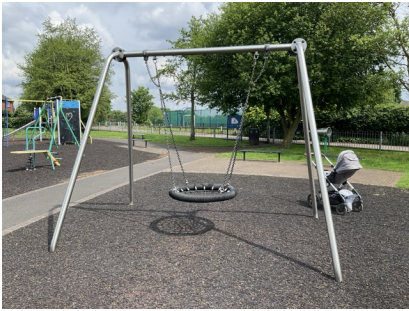
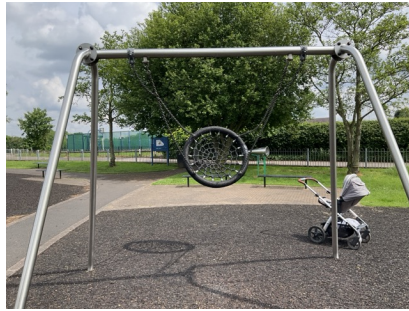
# Swing - Basket

Surface needs repair.

Foot drag is wearing under the basket. Plan repair of bonded rubber mulch.

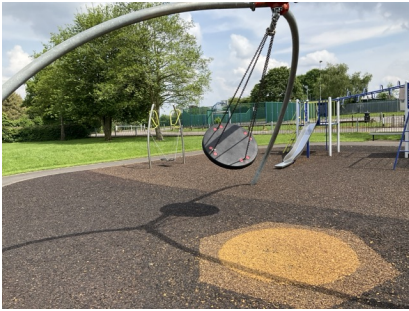
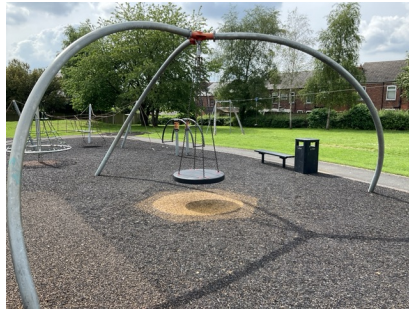
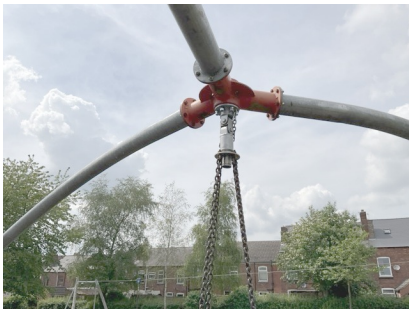
# Swing - Group - Large

Given forces involved with this asset the level of wear in the connectors now means there is a possibility of failure in the future. Replace connectors and attached chain links which in some cases are beyond 40% worn.

Read the notes for further action., Replace worn parts.

Neil C to replace-again can we ask Cliff for assistance on this

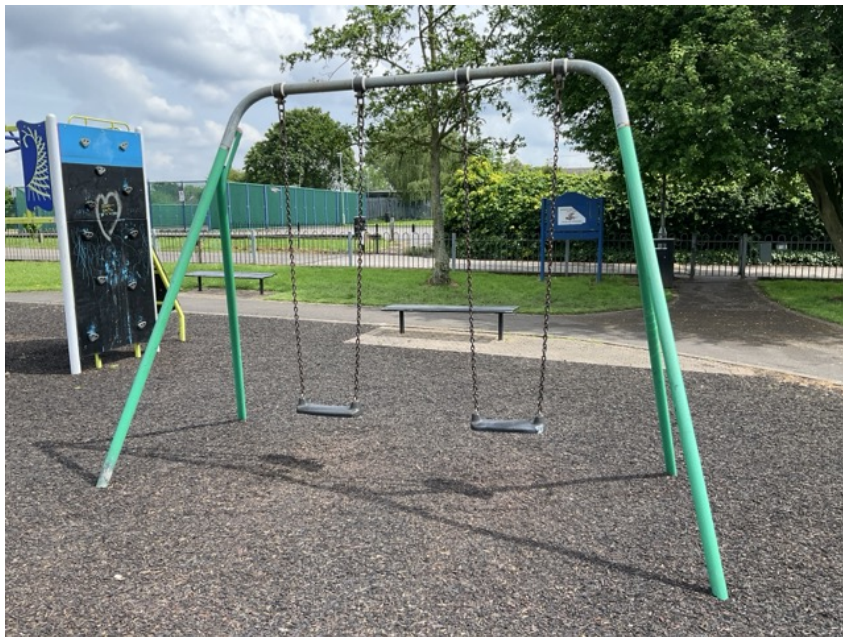
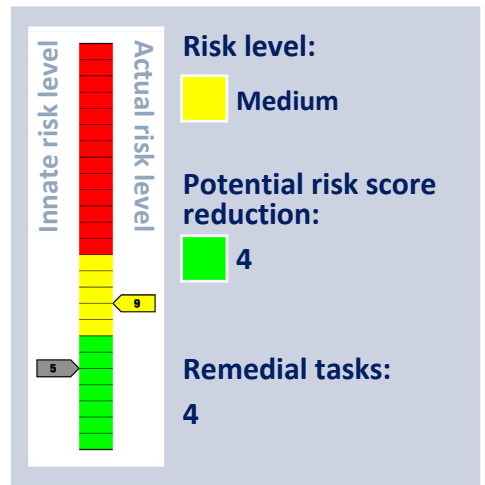
# Swing - Junior - 1 Bay 2 Seat

Some chain wear.

The swing seat has been damaged, but does not require immediate replacement.

Swing D-shackles are worn.

Plastic cover/bush worn through. Replace.

Monitor for further deterioration and replace before 40% wear.

Monitor and replace when hard material is exposed.

Read the notes for further action., Replace.

[Ask Neil C to replace-order any parts required](#)

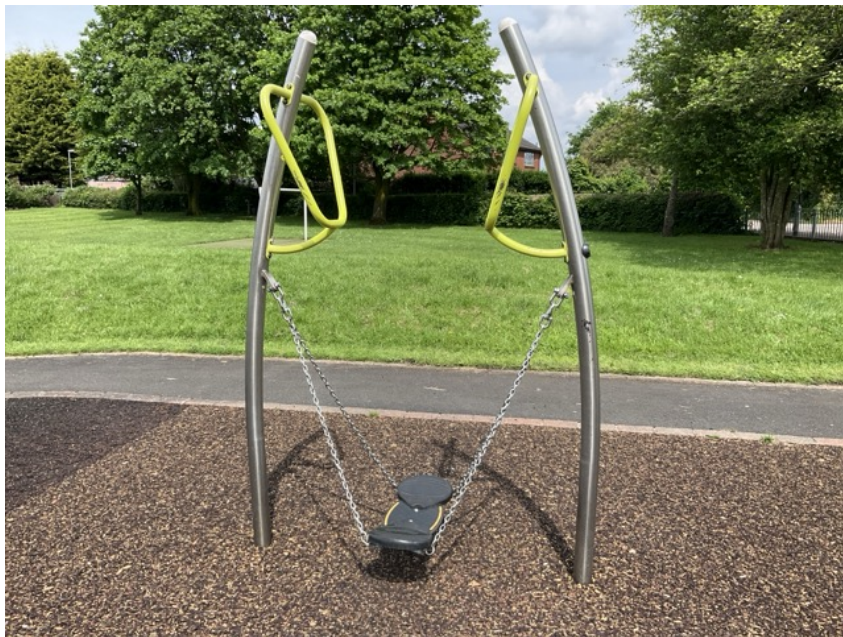
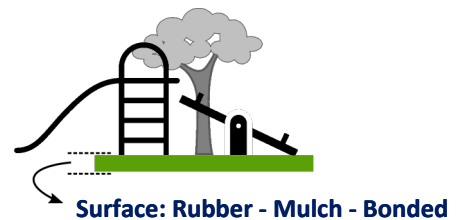
# Swing - Skate Rider

Loose in ground.

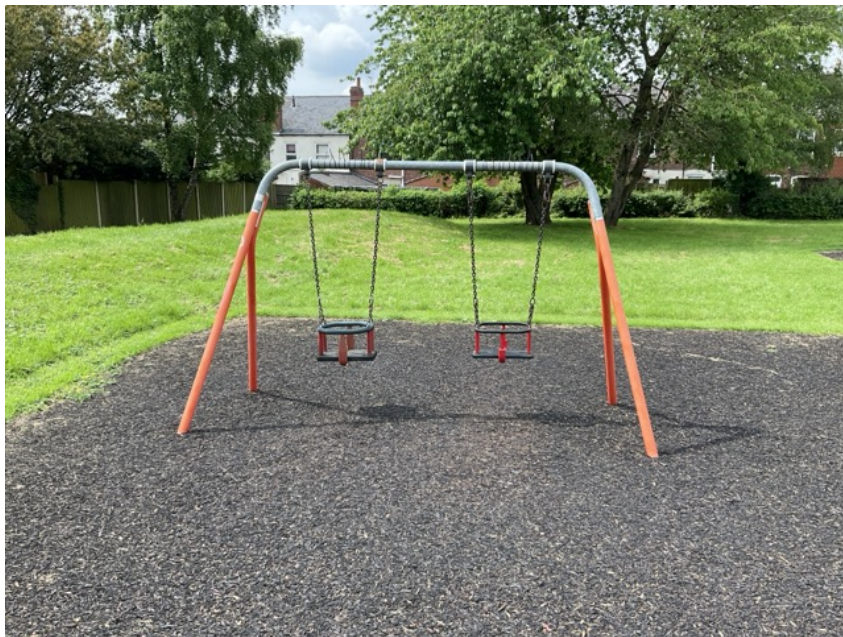
# Swing - Toddler - 1 Bay 2 Seat

Item has some parts missing.

Rubber fixing to D-rings. Schedule replacement.

Read the notes for further action., Replace the missing parts.
