Safety Inspection Report

Annual Inspection

Knowle Park Recreation Ground

17 May 2024

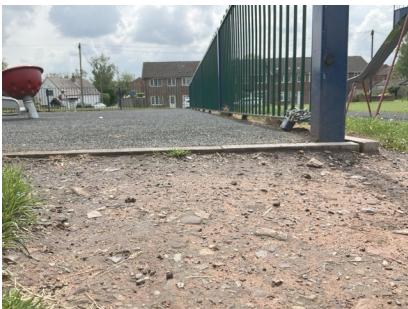
Gates

Trip points on the surface.

Neil to level this surface
