Safety Inspection Report

Annual Inspection

Knowle Park Recreation Ground

17 May 2024

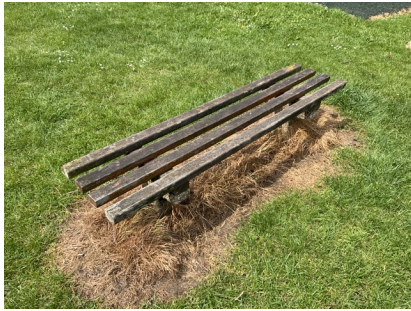
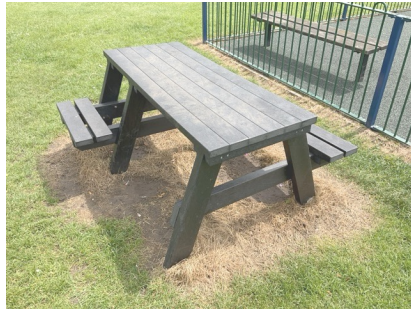
Seating

Hole(s) found.

Neil to fill in hole

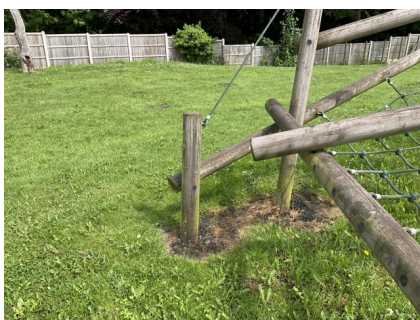
Strimmer damage is present on posts, allowing water to enter and timbers to soften. It can also remove the protective envelope around the timber. Prevent further damage and check timbers for decay throughout the year.

The post appears heavily strimmed. There is some decay setting in. Monitor as this may deteriorate quickly. Plan for replacement.

Prevent further damage., Read the notes for further action.

We need to find 3 quotes for replacement of this please Julie

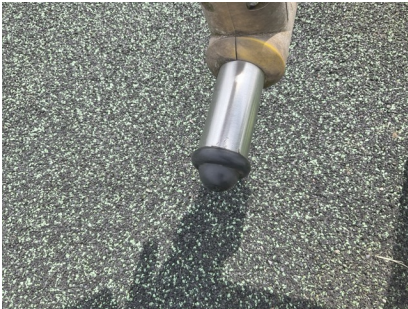
Rocker - Scooters x 2

Fixtures loose or missing.

Front of rocker bolt has loosened. Resecure.

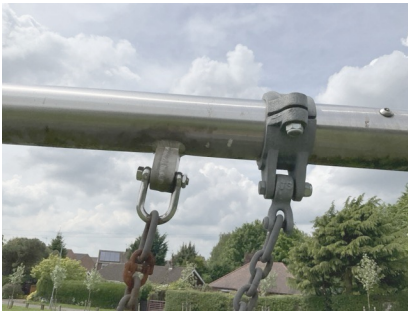
Swing - Basket

Cap missing.

Replace.

Again Neil C to replace caps please

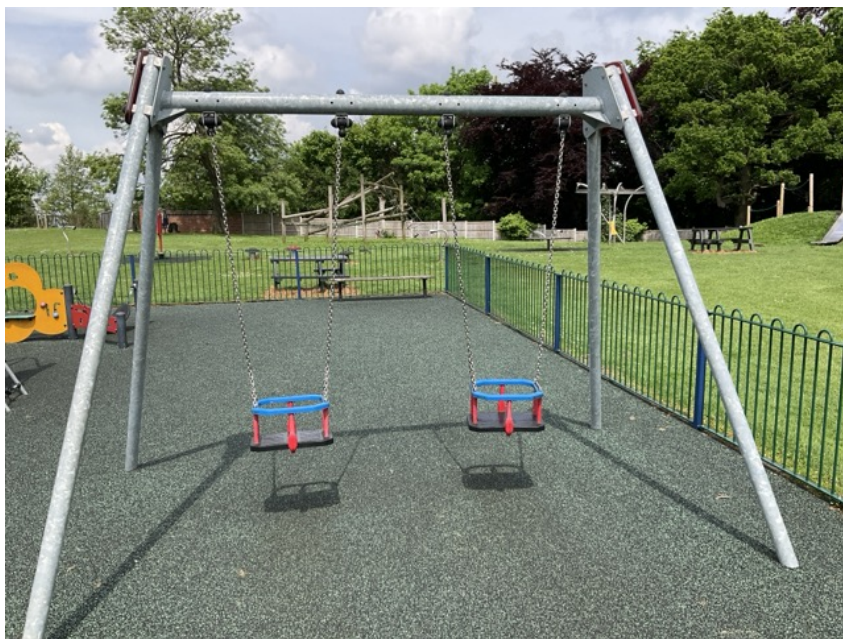
Swing - Toddler - 1 Bay 2 Seat

Metal bar securing swing suspension has bent. This has enabled the chain to slide along back to the other suspension. This creates an unstable swing and potential entrapment. Re-fit a new bar or replace the cradle.

Repair., Replace., Read the notes for further action.

Neil C to replace cradle with spare swing seat please

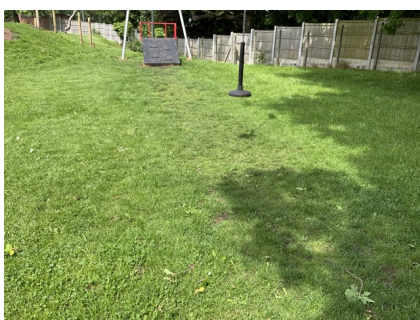
Cableway - Seated

Inspector advises cable is dismantled and serviced. Additionally this year the internals on the travellers appear to show signs of wear. Service the traveller.

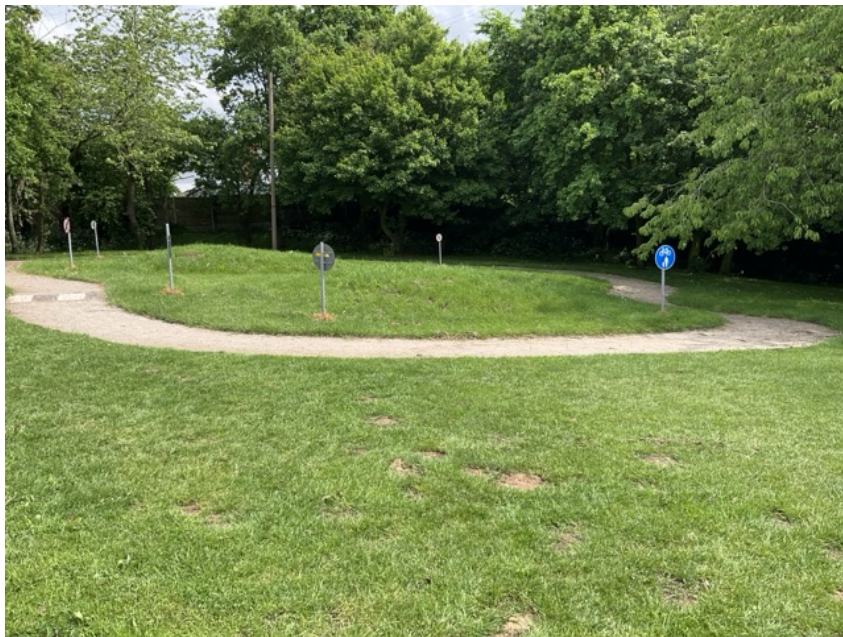
Cycle - Proficiency - Traffic Track

Surface needs repair.

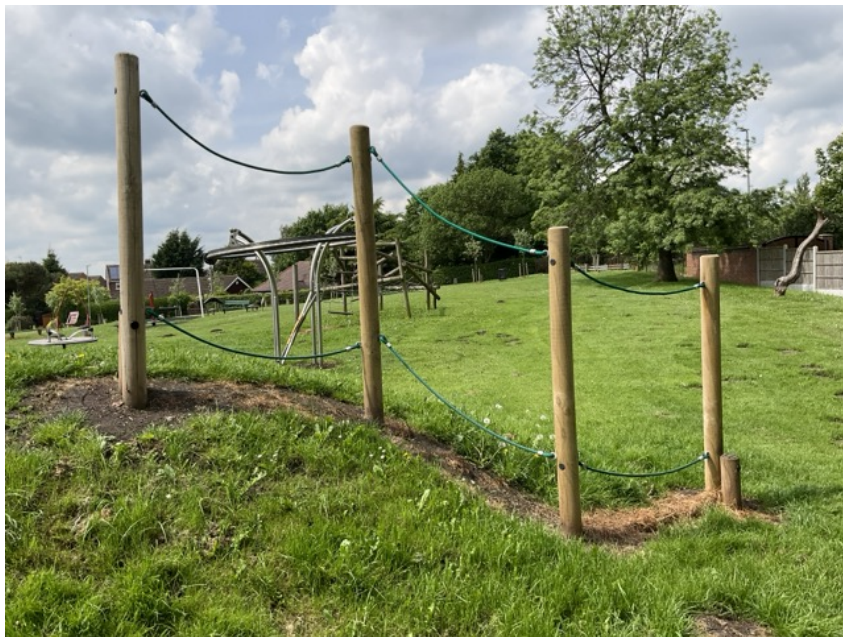
Climber - Traverse Rope

Loose in ground.
